City of San Marcos

Special Meeting Historic Preservation Commission April 23, 2020, 5:45 PM

Staff Report Historic Preservation Commission

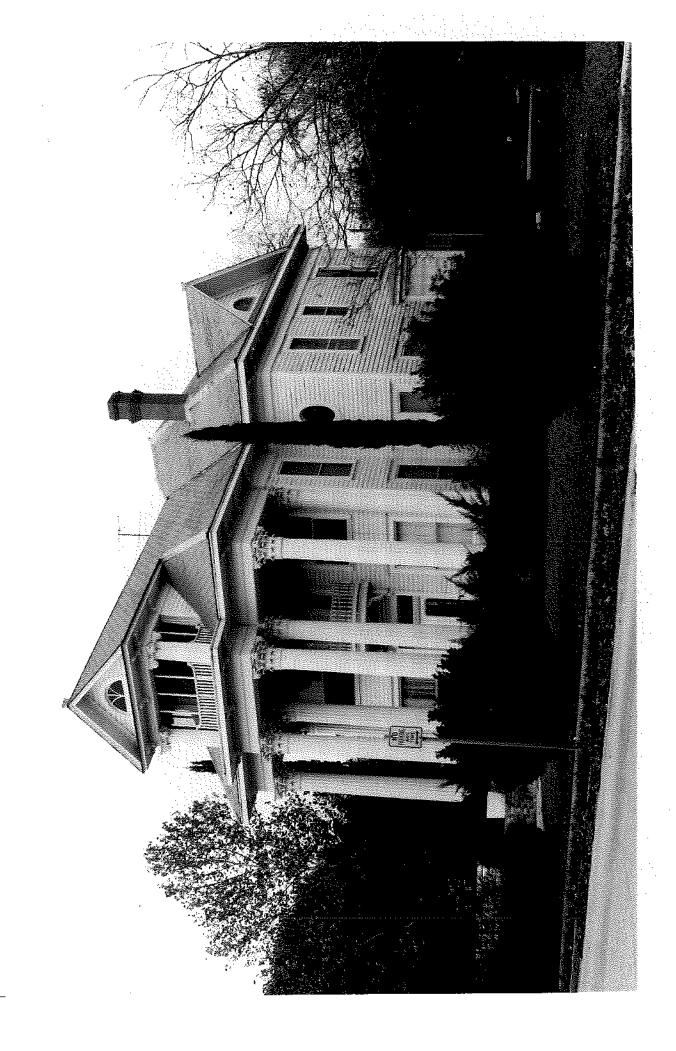
East oblique, camera facing west. Photo 112 of 150.

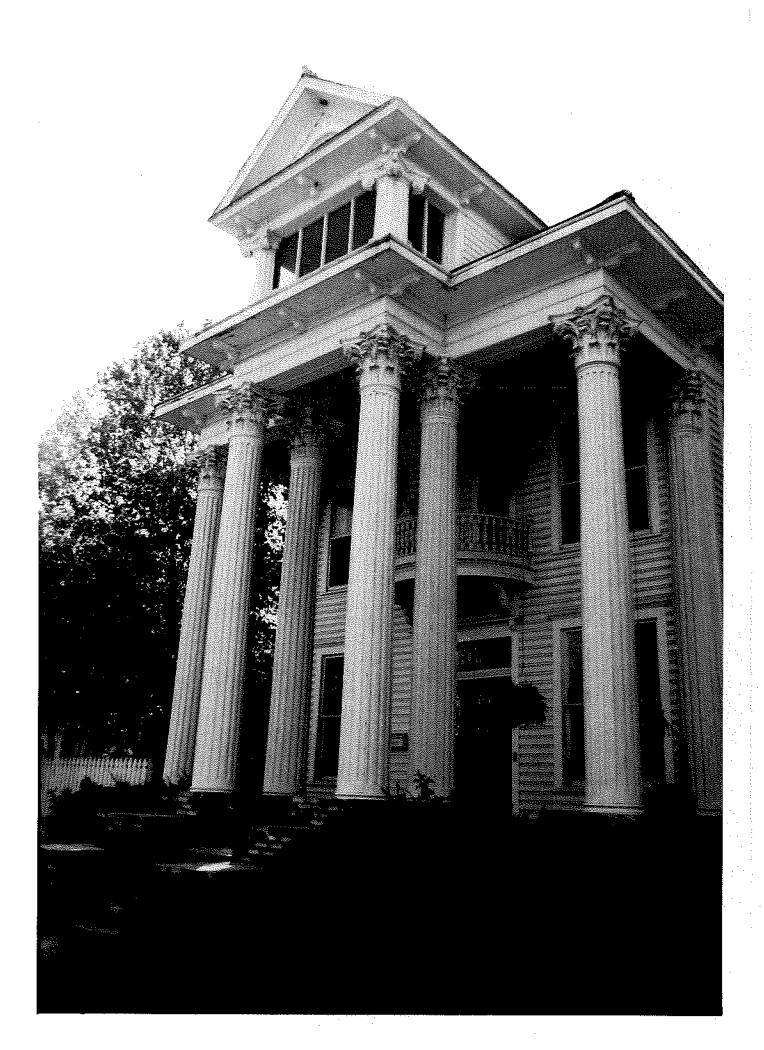
Detail of southeast facade, camera facing west Photo 114 of 150.

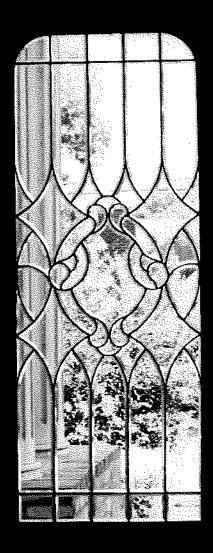
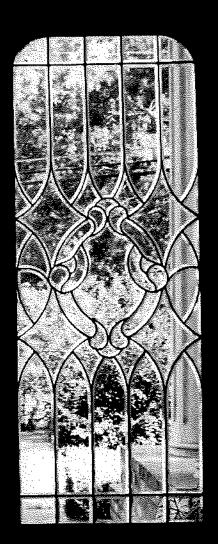
Detail of livingroom - front door. Photo 116 of 150.

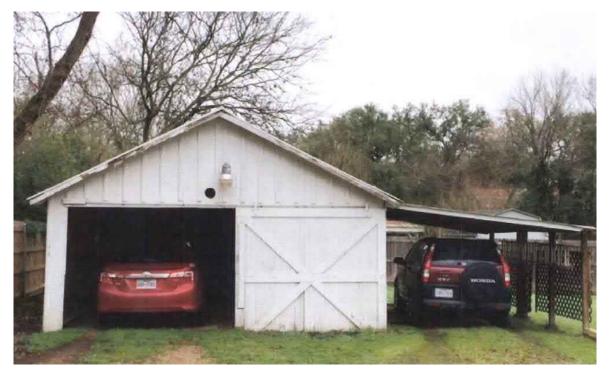
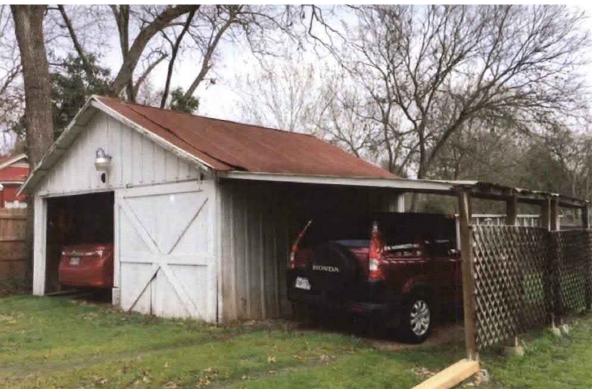
The applicant is proposing to demolish the existing detached garage located at the rear of the property; they state that the garage is deteriorating. The garage is listed on the historic resources survey form as being of historic age but does not give a date of construction of it. The applicant statest that the main garage is 18' wide by 16' deep, the size of a small two car garage, with an attached shade that measures 12' wide by 16' deep. The following photographs show the existing garage:

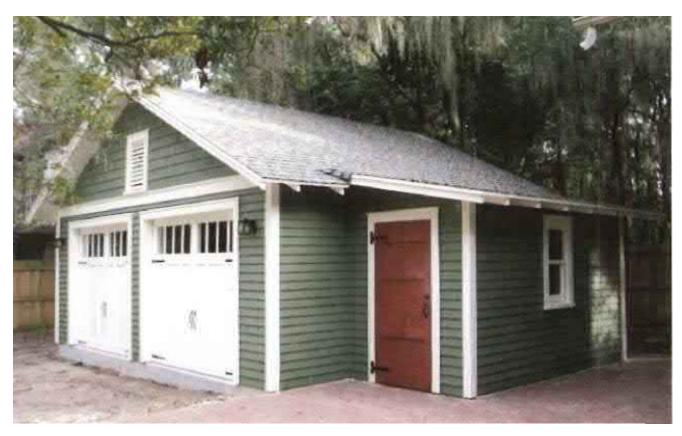
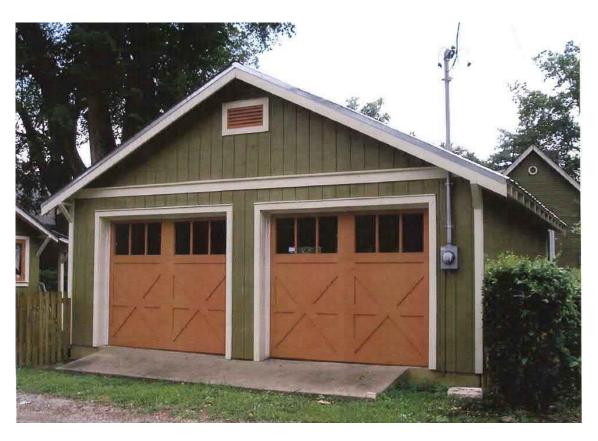
The applicant is proposing to replace the demolished garage with a slightly larger, wood framed, two car garage that will be located in the same place at the rear of the property. The applicant supplied the following photographs as examples of the two garages they have in mind for a replacement. The application states that the first garage is the applicant's preferred choice for construction as includes a similar side addition to the right of the garage doors as does their existing garage. The applicant sent the following dimension for the garage shown in the first picture: 24' by 24' deep, standard two car garage, with an attached tool room that measures 6' wide by 20' deep.

Section C.1.2.4(10) of the Historic District Design Guidelines recommend constructing garages to the rear of the property behind the face of the house. Staff finds the request consistent with this recommendation. While Section C.1.2.4(11) of the Historic the Design Guidelines recommends orienting garage doors away from the street, the new garage doors will be in the same orientation as the existing ones which face West Hopkins Street. Staff finds the request to keep the garage door orientation helps to maintain the historic integrity of the site, consistent with Section 4.5.2.1(I)(1)(e) of the San Marcos Development Code. Section C.3.2.5(C) reiterates that garage placement and approach should respect the original "front line" of the house. Staff finds the placement of the new garage in the same location at the rear of the property consistent with this. Staff finds the request for the new garage consistent with Section C.3.2.6(C)(13) which recommends to install single car garage doors instead of double wide doors. Sections C.3.4.5(A) and C.3.4.5(B) of the Historic District Design Guidelines state that wood was the primary building material in residential construction and that board and batten, a vertical siding, is commonly used on outbuildings such as garages. The existing garage is a board and batten garage. Neither example of the garages provided by the applicant show board and batten siding. However, if the applicant's chose a siding that matched the profile of the main residence that would meet Section 4.5.2.1(I)(1)(g) of the San Marcos Development Code. Staff also finds that locating the garage in the same location as the existing one meets the Secretary of the Interior's Standards for Rehabilitation Standard Number 9 which states "New additions, exterior alterations, or related new construction will not destroy historic materials, features, and spatial relationships that characterize the property. The new work will be differentiated from the old and will be compatible with the historic materials, features, size, scale and proportion, and massing to protect the integrity of the property and its environment."

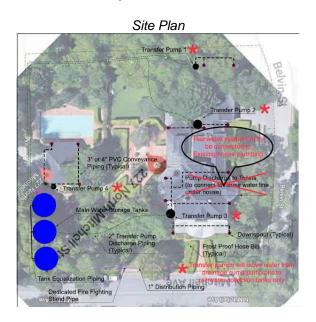
The applicant is proposing to install a rainwater collection system on the property which will consist of three (3) metal collection tanks, a series of piping, and transfer pumps. The piping and the transfer pumps, as shown in the site plan appear to be shielded from the right-of-way; a full size site plan has been included in the packet as "EXHIBIT C".

The proposed tanks, shown in blue on the site plan above, are proposed to be located along the northeast property line, most visible from the North Johnsons Avenue right-of-way as shown below:

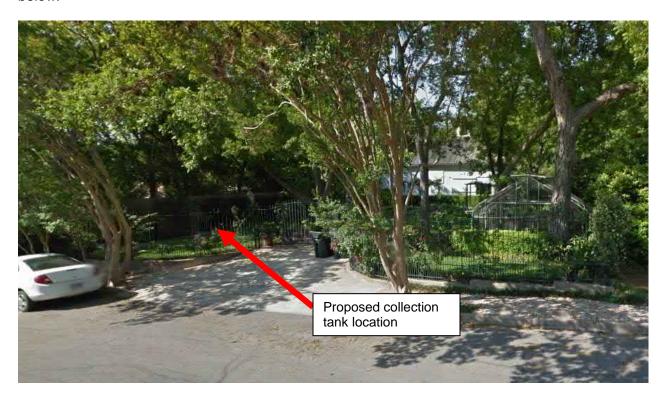
According to the applicant, the rainwater collection system contractor, each tank measures 10' 7" to the top of the tank walls, or the eve. The dome is about six-inches to the top of the highest point of the tank roof or peak. From the road the tanks will appear to be about 12 feet tall as they will be located in a sandpad that is a couple feet high at the highest point. The company offers the rainwater tanks in a variety of colors. The three proposed tanks will be "Cottage Green" in order to blend in with the landscaping. Below are photos from the brochure of the types of tanks and color palette offered by the company.

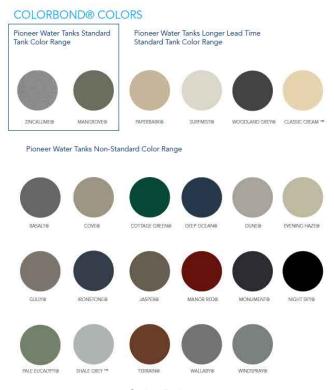
Example of metal rainwater collection tank

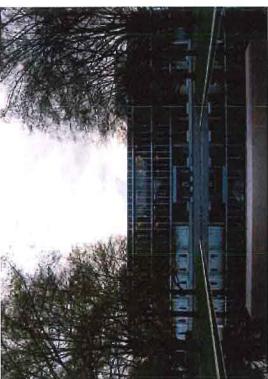
Not Recommended: [97] This tree, which was planted too close to the building, has caused the masonry wal to retain moisture that damaged the mortar and required that the brick be repointed in this area.

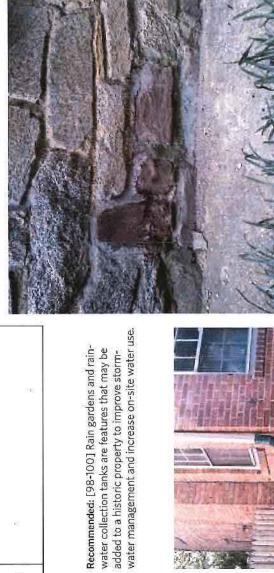
Not Recommended: [107] Splash back from the impermeable concrete paving next to the foundation is damaging these stones.

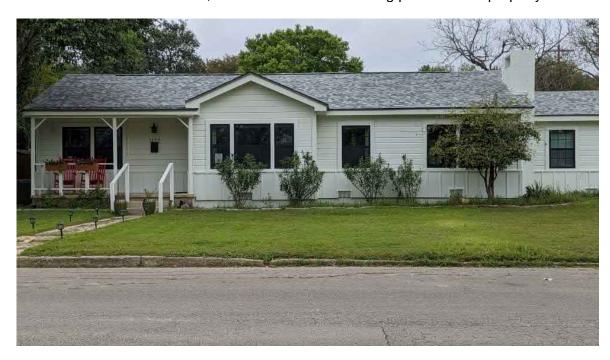
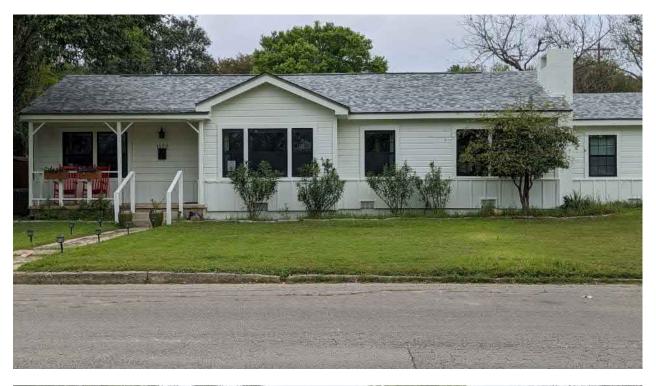
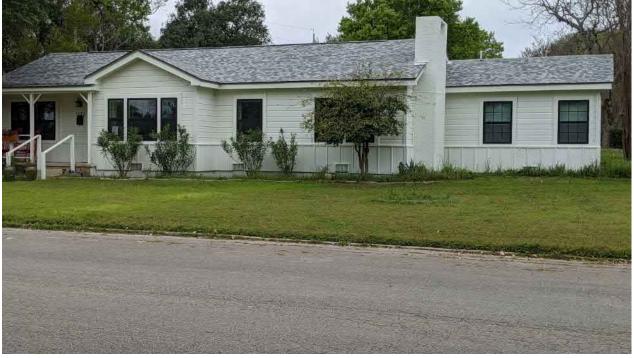
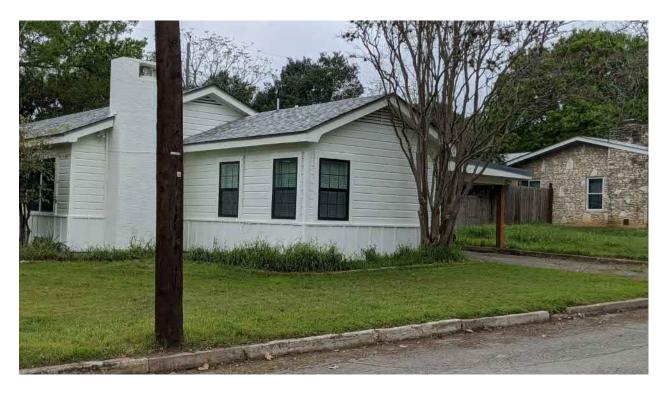
On February 28, 2020, Permit Center staff received a complaint about work being conducted on the property. A City of San Marcos Building Inspector was sent to the site and issued a Stop Work Order for exterior work performed in a historic district without approval from the Historic Preservation Commission or a permit. By the time the Stop Work Order was issued, the windows had been replaced as well as the siding. While a building permit is not required for the replacement of the windows, siding, and painting, an approved Certificate of Appropriateness (COA) is required for the replacement of the windows and the siding. Painting a residential structure is exempt from requiring a COA. Staff was in contact with the property owner in early March and they subsequently submitted a COA application.

Staff visited the site on March 16, 2020 and took the following photos of the property:

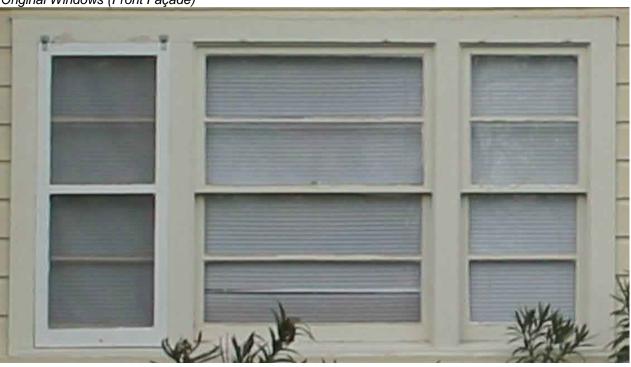
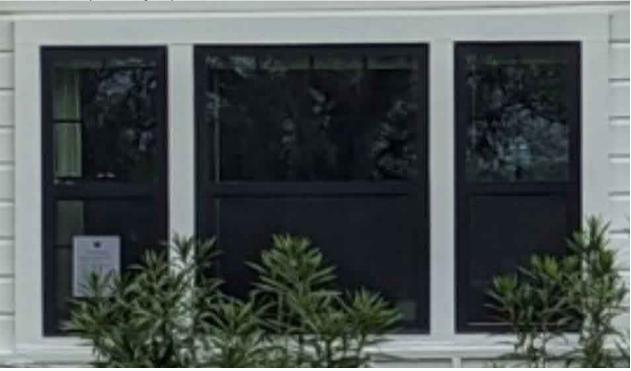
Original Windows (Front Façade)

Section C.3.3.5(A) of the Historic District Design Guidelines states that windows play an important role in the character definition of houses and the overall neighborhood. The detail of the window is frequently a key characteristic in identifying an architectural style. The proportion, material and organization of windows in the wall help to establish a construction date of the house and the detail of the window is frequently a key characteristic in identifying an architectural style.

Staff finds the request to replace the original wood windows with vinyl windows is not consistent with the recommendation in Section C.3.3.5(D)(1) to retain original windows as they are a strong character defining feature on a house. Staff finds that the request is somewhat consistent with the recommendation in Section C.3.3.5(D)(4) to replace missing windows or frames that are deteriorated beyond repair with windows of the basic dimension and profile. The applicant chose replacement windows that were the same dimension as the originals and the framing does not seem to have been altered. However, the new windows have been installed flush with the frames and the light pattern of the panes of glass is very different from the original windows. The new windows have a divided light pattern where the originals did not. Staff finds that replacement of all the windows is not consistent with the recommendation in Section C.1.2.5(F) which explains that if one window is beyond repair, there is no need to replace all windows in the building.

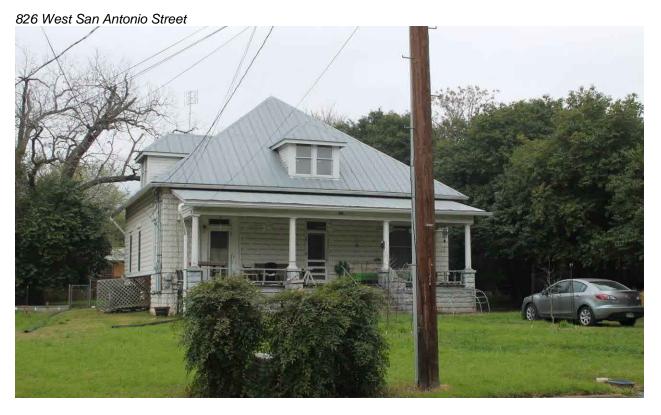
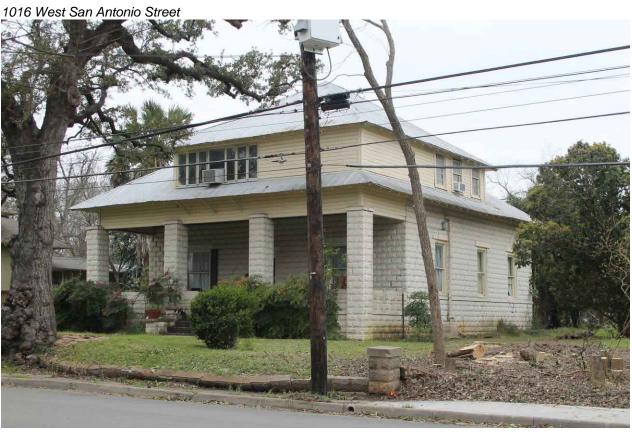
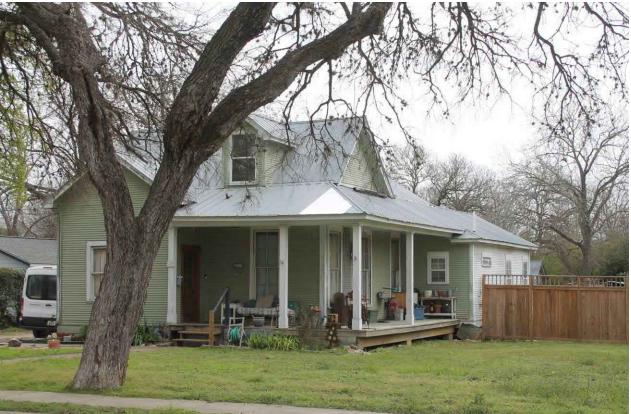
There are several homes in the district with metal roofs as shown in the photos below:

Section C.3.3.6(C) of the Historic District Design Guidelines state that roofing is one material which might need to be replaced rather than repaired and notes that a new roof will be necessary at some point in the future. Section C.3.3.6(E) states that a variety of roofing materials have been installed in San Marcos, including standing seam and corrugated metal sheets. Section C.3.4.2(A) explains that the primary use of metal on residential homes in San Marcos was as a roofing material or in roof related decoration. This is evident as there are several other houses that have standing seam metal roofing in the immediate area around this house as well as in the other historic districts in San Marcos. Staff finds the request consistent with Section 4.5.2.1(I)(1)(g) and 4.5.2.1(I)(1)(h) of the San Marcos Development Code. The proposed metal roof is visually compatible with other buildings in the district and the roof form is not proposed to be changed.
